Comprehensive conservation and restoration of two frames for the temple icons of the Sampson Cathedral in St. Petersburg

Annotation: The article is devoted to the restoration of two carved gilded frames to the temple icons of the 1760s in the Rococo style, during the work on which the techniques of conservation, restoration, reconstruction and recreation associated with the severe physical condition of the objects of church decorative and applied art received in the restoration were comprehensively applied. The purpose of the study and practical work was to return the expositional appearance of church objects of decorative and applied art as monuments of cultural heritage of Russia. During the study part of the project, printed and handwritten materials of many Russian experts in art and restoration, including Andrei Petrovich Aplaksin, a member of the Imperial Archaeological Commission, author of the restoration project of the Sampson Cathedral in 1908-1909, diocesan architect-restorer, civil engineer, artist, archaeologist, historian of Russian architecture, writer, were studied. Thanks to the well-coordinated and consistent restoration and restoration processes performed on the

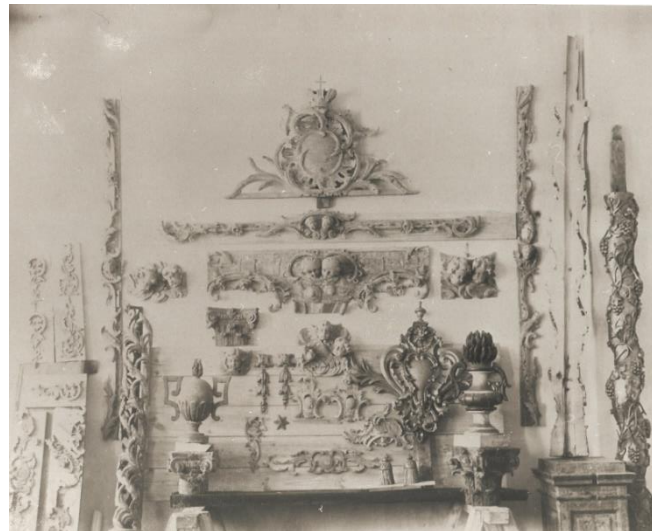
Figure 5. Details of the frames for the temple icons and the altar Canopy of the Sampson Cathedral in the process of restoration in the workshop. 1908.

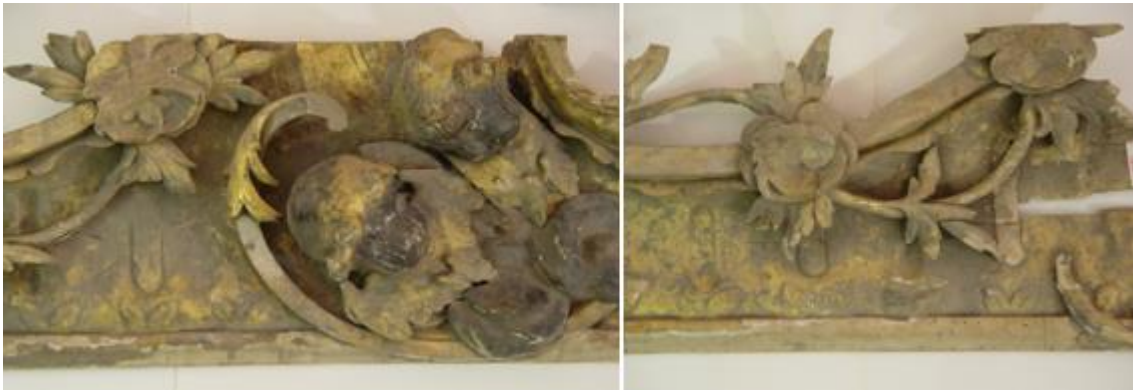
Figures 8-9. The loss of fragments of the carved decor of the frame and strong persistent surface contamination of the surface of the frame parts

alternately with an interval of one year. It was simply impossible to call the fragments brought in bags frames. They were dirty, shapeless pieces of old wood decrepit from time and lack of storage conditions. These fragments were listed as fragments of the once gilded frames for temple icons, but no gilding was visible under the thick layer of dirt and dust that had accumulated over decades and eaten into the surface. The condition of these fragments could be assessed as extremely emergency (*Figures 8-18, 29, 45, 49, 53, 54, 57, 59, 61, 64*).

The loss of the base consisted of shapeless pieces with oblique chips. It was not possible to simply glue them together due to the loss of numerous small connecting fragments. Quite a few fragments of carved decor were deformed due to the fact that they lost contact with each other, and many fragments from the influence of dampness and temperature changes for a long time received deformations and structural destruction of the base wood, such as uneven looseness and shrinkage of wood along the fiber (*Figures 8-18, 29, 45, 49, 53, 54, 57, 59, 61, 64*).

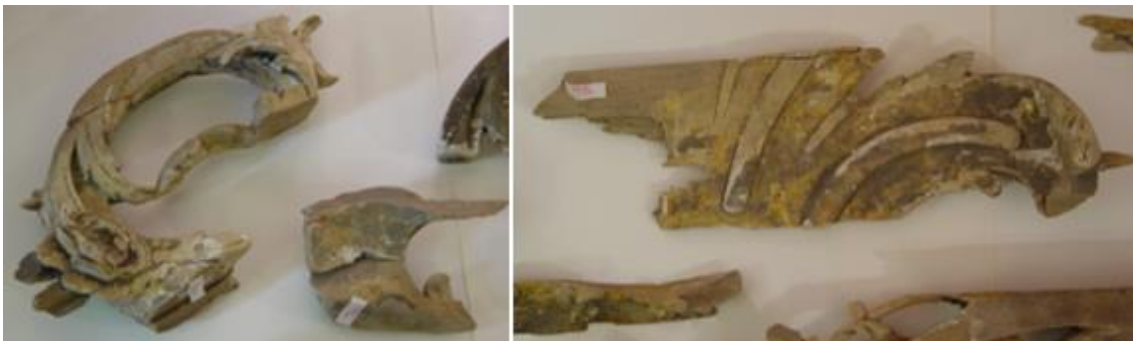
Figures 10-11. The loss of fragments of the carved decor of the frame and strong persistent surface contamination of the surface of the frame parts

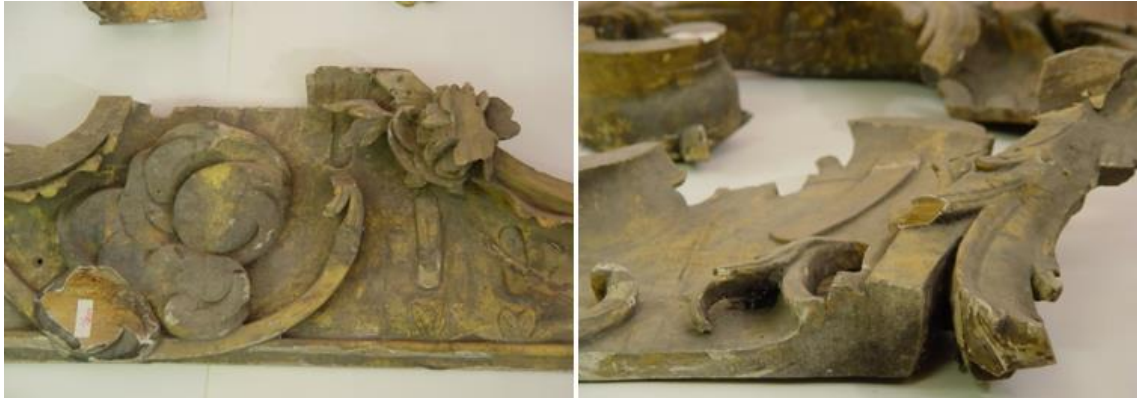
Figures 12-13. The loss of fragments of the carved decor of the frame and strong persistent surface contamination of the surface of the frame parts

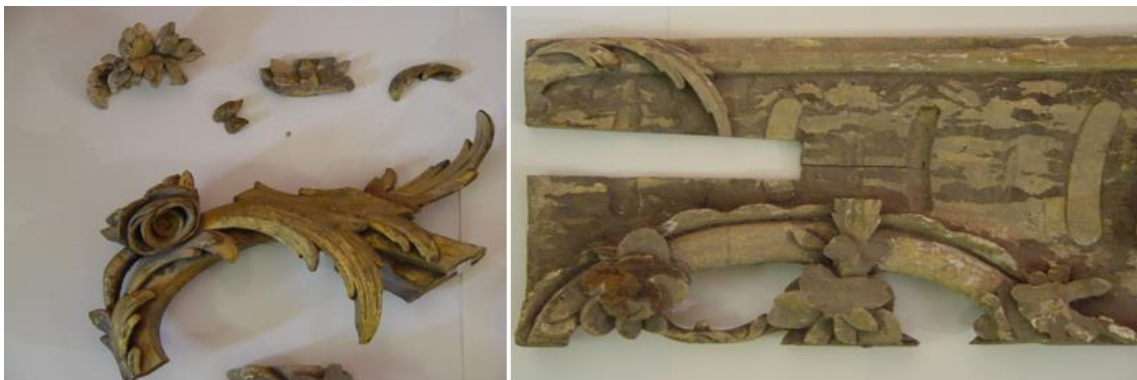
Figures 14-15. The loss of fragments of the carved decor of the frame and strong persistent surface contamination of the surface of the frame parts

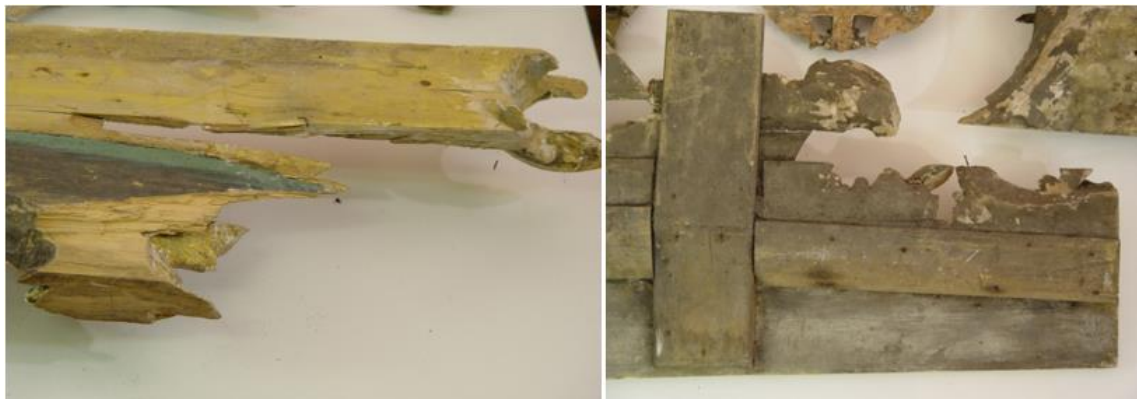
Figures 16-17. The loss of fragments of the carved decor of the frame and strong persistent surface contamination of the surface of the frame parts

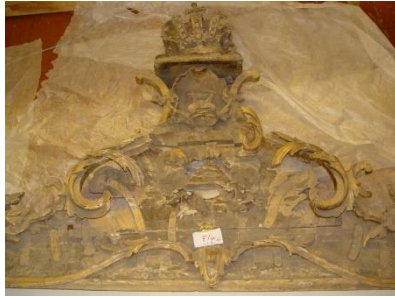
Figure 18. Frame for the temple icon *Nicholas the Wonderworker in Life*. The top listel is used before the restoration of the foundation and the restoration of its losses

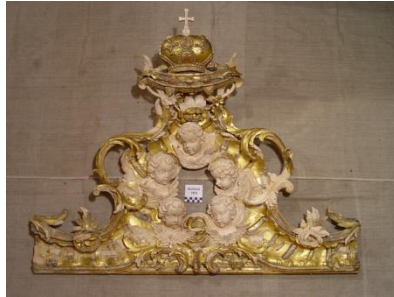
Figure 19. The frame for the temple icon *Nicholas the Wonderworker in Life*. The upper listel after the restoration of the loss of sculptural and ornamental decor

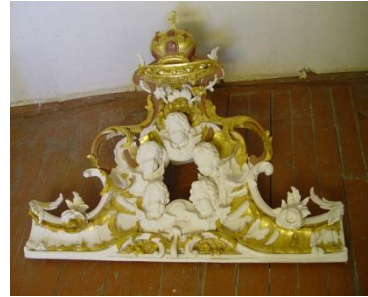
Figure 20. Frame for the temple icon *Nicholas the Wonderworker in Life*. The upper listel is in the process of restoration: local reconstruction of the losses of the levkas and removal of persistent surface contamination while preserving the historical gilding of 1909

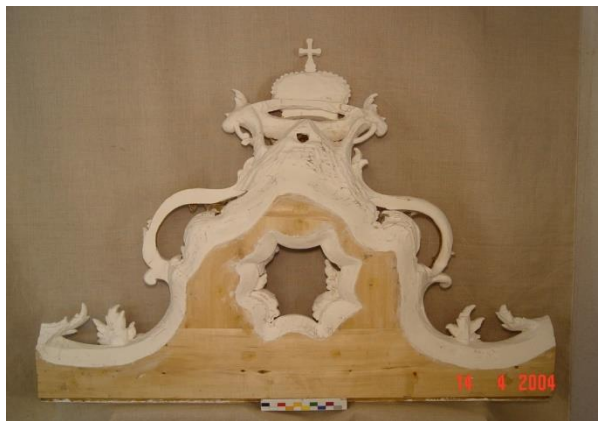
Figure 21. The frame and the temple icon *Nicholas the Wonderworker in Life*. The back side of the upper listel with a duplicated base in the process of recreating the lost ground-levkas

Next step there was duplication on a new basis. The carvers prepared linden wood veneer of the required thickness (about 3 cm) to perform this technological operation. On a new basis, gradually supplementing the missing reconstructed fragments of the frame with the preserved historical elements, they assembled dry all the sheets of the frame, fitted the fragments at the gluing points tightly to each other. Only after that, the elements were glued to each other and to the new basis to give the composition mechanical strength. According to this technique, all listels of two frames were duplicated. The work on the most complex detail of the frame composition – the upper listel – consisted in duplicating the base on new wood due to the dilapidation of the historical base and a large number of losses (*Figures 21, 50, 63*).

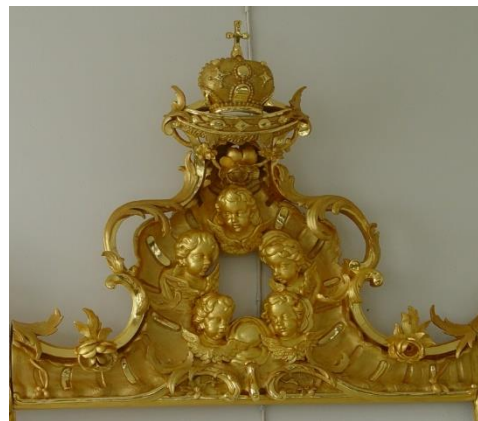
Figure 22. The frame for the temple icon *Nicholas the Wonderworker in Life*. The upper listel after performing a complex of conservation and restoration works

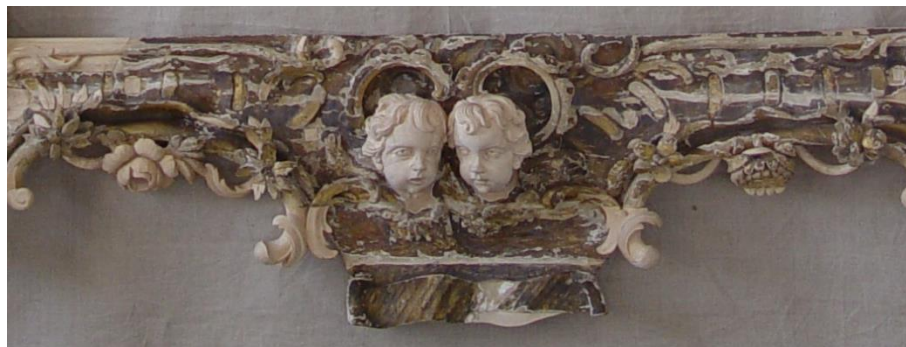
Figure 23. Frame for the temple icon *Nicholas the Wonderworker in Life*. The lower listel before the preservation of the historical soil and the removal of persistent surface contamination in the process of replenishing the loss of sculptural and ornamental decor

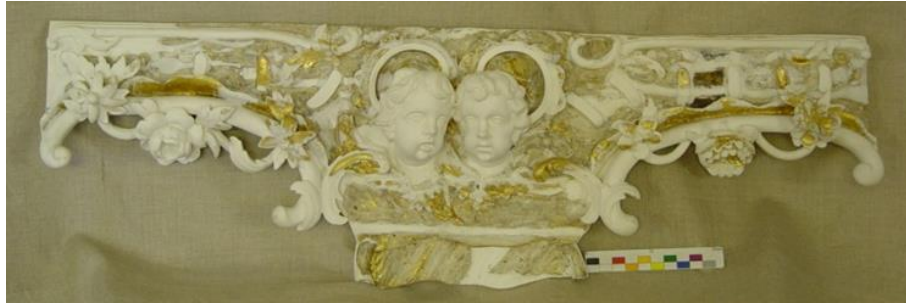
Figure 24. Frame for the temple icon *Nicholas the Wonderworker in Life*. The lower listel after the preservation of the historical soil, local replenishment of its losses and removal of persistent surface contamination

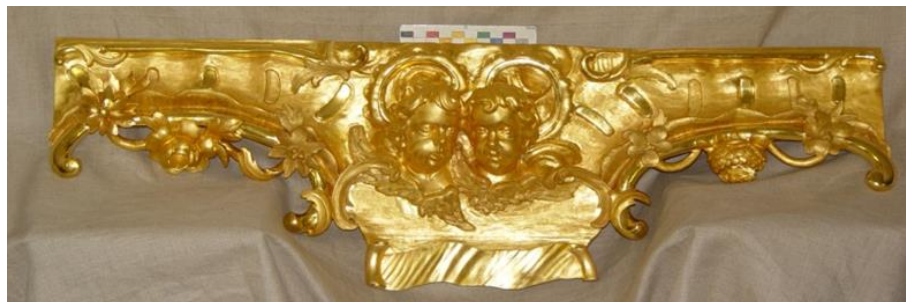
Figure 25. Frame for the temple icon *Nicholas the Wonderworker in Life*. The lower listel after a complex of conservation and restoration works

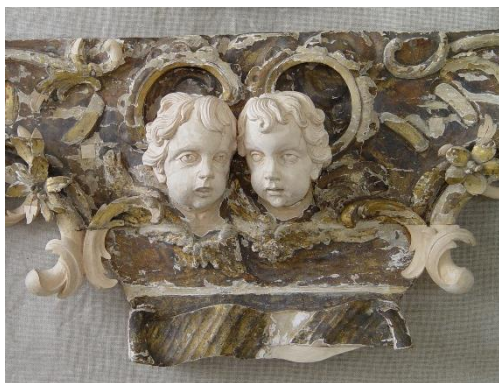
Figure 26. Fragment – the center of the lower leaf of the frame to the temple icon *Nicholas the Wonderworker in Life* before the conservation and restoration of the levkas and gilding, after the restoration of the loss of ornamental and sculptural wood carving

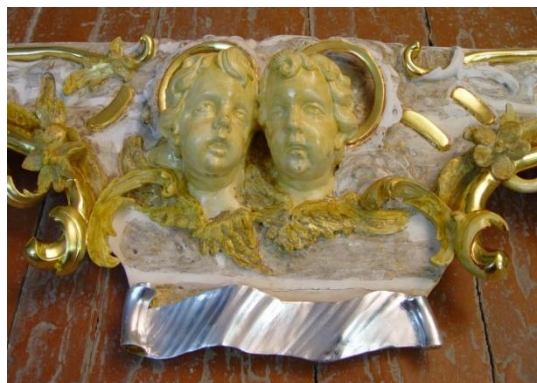
Figure 27. Fragment – the center of the lower leaf of the frame to the temple icon *Nicholas the Wonderworker in Life* in the process of resetting the decorative trim with a silver gilt lining on the ribbon, as an analogue of historical decoration

In the technology of the 18th century, there was silver under the entire matte gilding surface, since at that time they gilded the so-called “double”, bimetallic plates, one side of which was silver and the other was gold. In the 19th century, the “double” was replaced for simplicity with adhesive silvering of the matte areas surface, on top of which glue gilding was performed, which gave almost the same effect. In our case, the masters of the early 20th century did not do this work for two reasons: firstly, they had little time (only seven months); and secondly, the restoration leaders of that period did not see the difference in the shades of gilding on silver and without it. This is written in A.P. Aplaksin's report (*Figure 27*).

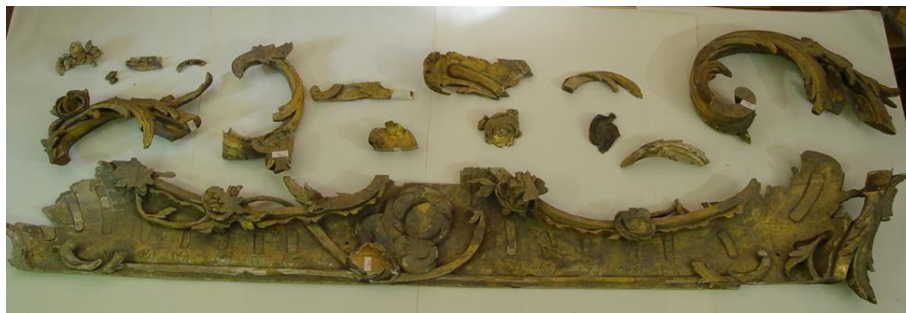
Figure 29. The left frame listel to the temple icon *Nicholas the Wonderworker in Life* before the restoration of the loss of the base with characteristic strong persistent surface contamination of the base and historical gilding

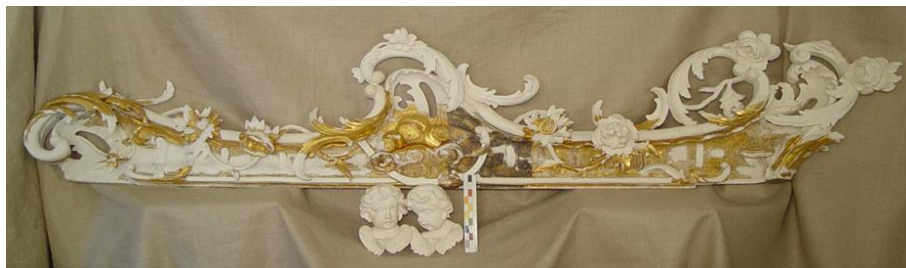
Figure 30. The left frame listel to the temple icon *Nicholas the Wonderworker in Life* in the process of preserving the historical levkas and local reconstruction of its losses with the control of clearing the surface from persistent contamination (in the center)

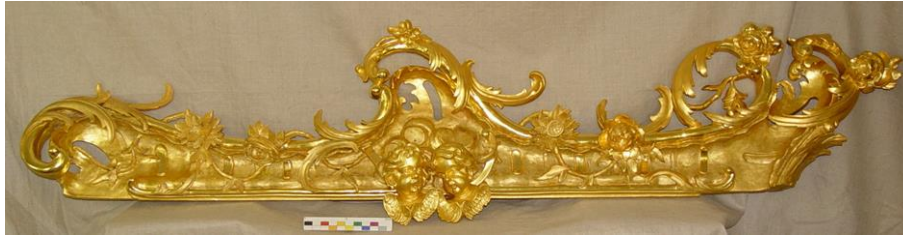
Figure 31. The left frame listel to the temple icon *Nicholas the Wonderworker in Life* after a complex of restoration works

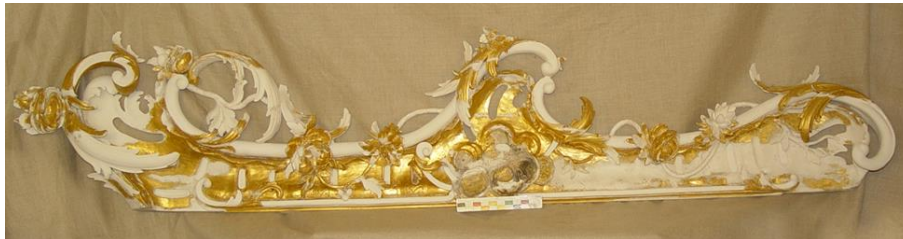
Figure 32. The right frame listel to the temple icon *Nicholas the Wonderworker in Life* in the process of preserving the historical levkas and local reconstruction of its losses, with the surface cleared of persistent contamination of historical gilding

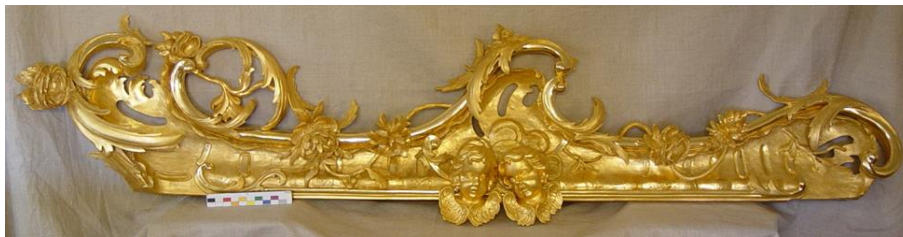
Figure 33. The right frame listel of the to the temple icon *Nicholas the Wonderworker in Life* after the preservation of the historical levkas with gilding, local soil replenishment. Gilding of two types and tinting of restoration gilding to match the color of the historical

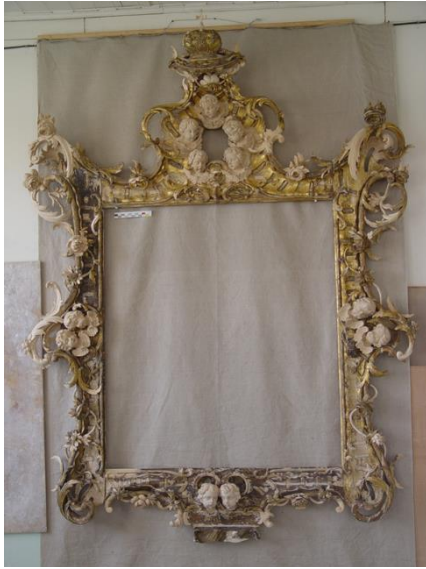
Figure 34. General view of the frame for the temple icon *Nicholas the Wonderworker in Life* in the assembly after a comprehensive restoration of the foundation and reconstruction of the loss of ornamental and sculptural carved decor

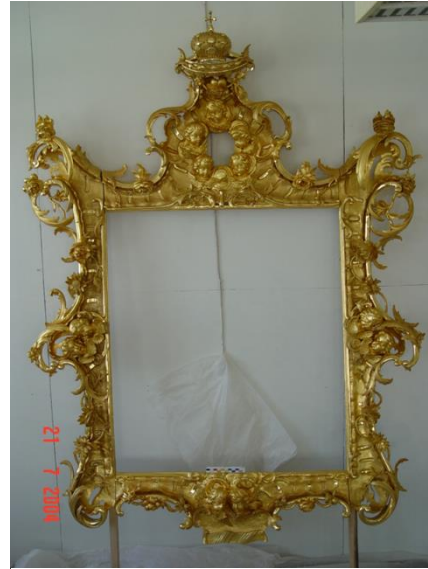
Figure 35. General view of the frame for the temple icon *Nicholas the Wonderworker in Life* in the assembly after a comprehensive restoration of the base and decorative decoration in the form of gilding

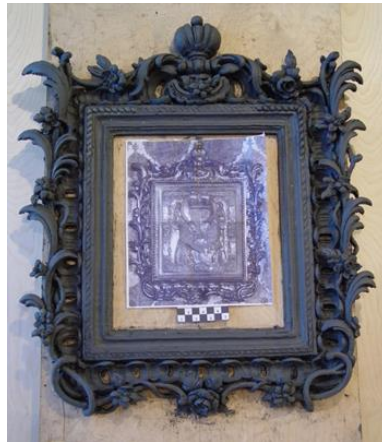
Figure 37. Reconstruction of the lost small frame to the image of *Nicholas the Wonderworker* based on the photo of K.K. Bulla in 1909. Execution of the model in a soft material

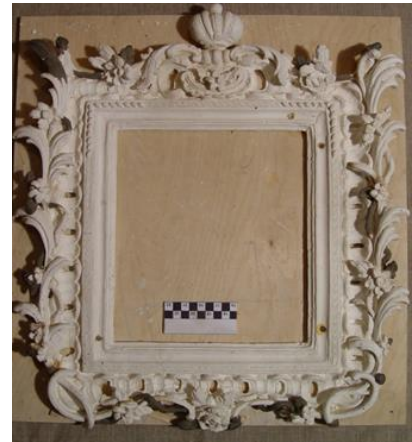
Figure 38. The transfer of the model from soft material to plaster to continue working in the authentic material of the monument – the wood of the linden tree

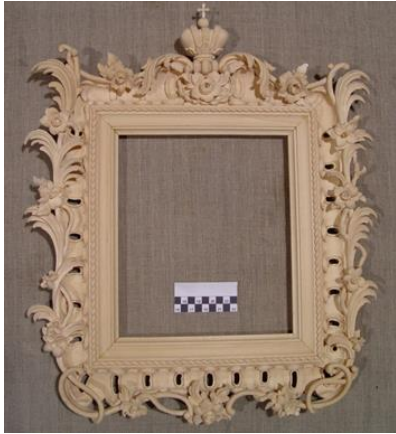
Figure 39. Execution of the frame to the image of *Nicholas the Wonderworker* according to the model in the wood of the linden tree

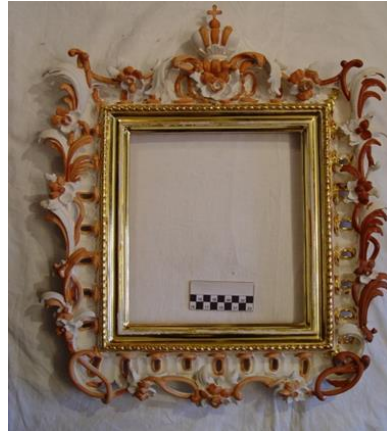
Figure 40. Reconstruction of the ground-levkas on the recreated frame to the image of *Nicholas the Wonderworker*. Designation of places of glossy gilding on the polymer

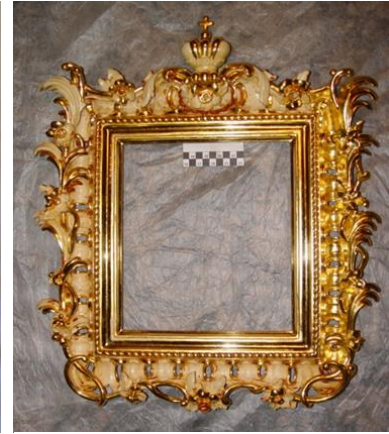
Figure 41. Performing glossy gilding on a polymer and covering areas of future matte gilding with alcohol shellac varnish

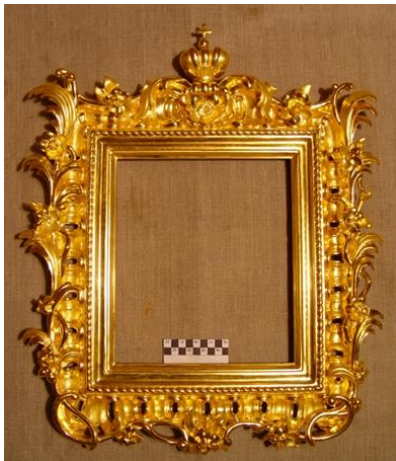
Figure 42. Execution of glossy gilding on a polymer and matte on a gulfarb, followed by tinting of restoration gilding to match the color preserved on the large frame to the icon *Nicholas the Wonderworker in Life*

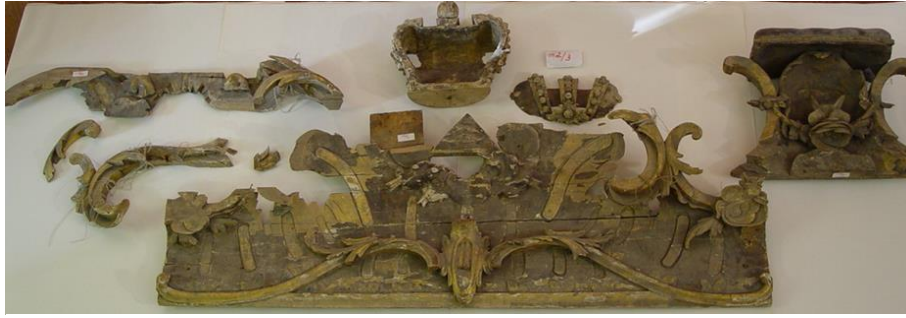
Figure 45. The frame for the icon *Mikhail Malein and John the Warrior* before the restoration of the base during the selection of authentic fragments for the restoration of the carved decor

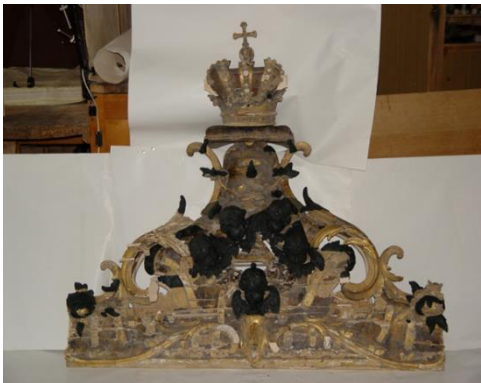
Figure 46. The upper frame listel to the temple icon *Mikhail Malein and John the Warrior* before the restoration of the losses of carved and sculptural decor with losses made up in soft material-plasticine

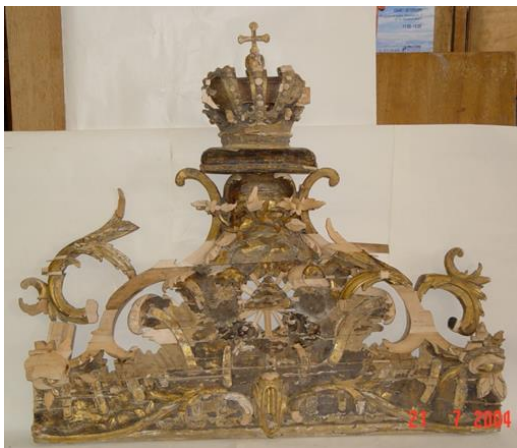
Figure 49. The upper frame listel to the temple icon *Mikhail Malein and John the Warrior* after the restoration of the loss of carved and sculptural decoration in the authentic material of the monument – linden wood

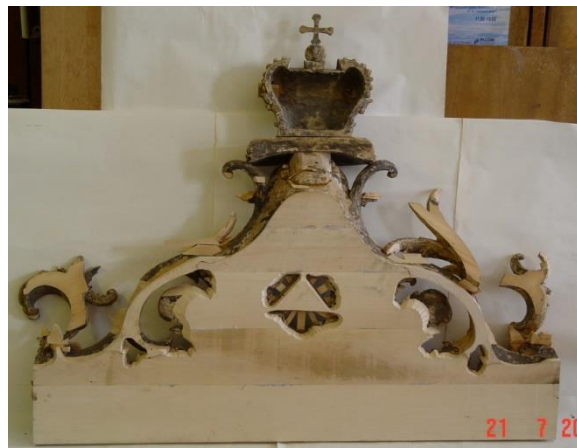
Figure 50. The back side of the upper frame listel to the temple icon *Mikhail Malein and John the Warrior* after duplicating the original carving of the 18th century on a new foundation

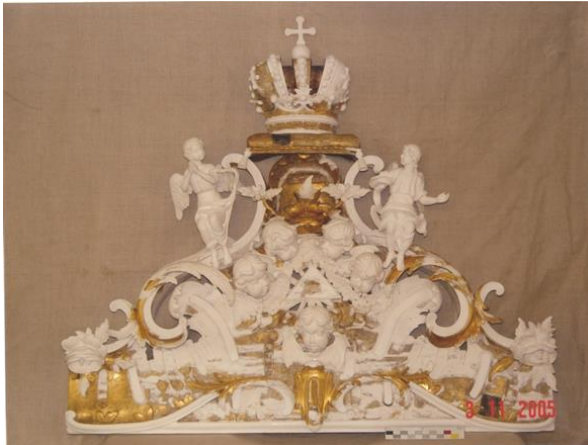
Figure 51. The upper frame listel to the temple icon *Mikhail Malein and John the Warrior* after the restoration of the loss of carved and sculptural decoration, local reconstruction of the lost ground-levkas

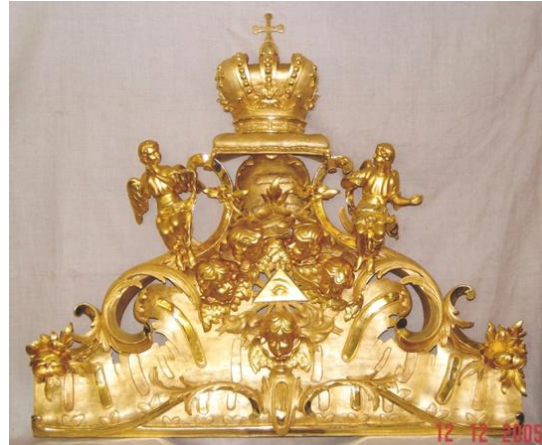
Figure 52. The upper frame listel to the temple icon *Mikhail Malein and John the Warrior* after the restoration of the loss of carved and sculptural decoration, local reconstruction of the levkas and local decorative gilding on the polymer and lacquer with tinted restoration gilding to match the color of the preserved historical

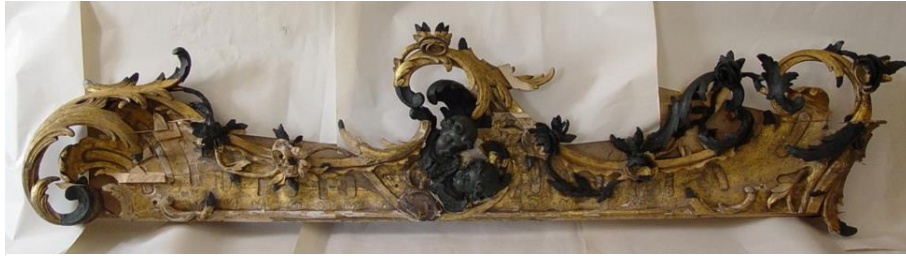
Figure 55. The left frame listel to the icon *Mikhail Malein and John the Warrior* in the process of modeling the loss of carved and ornamental decor

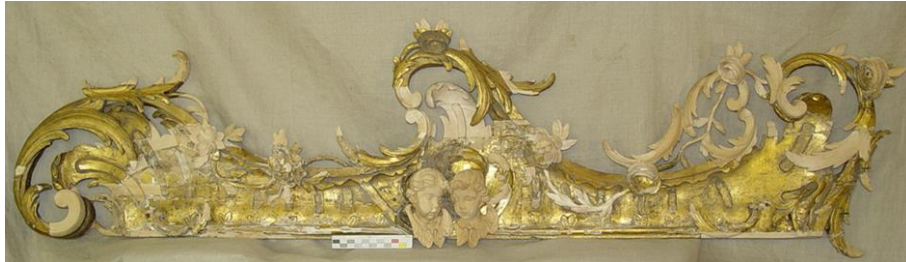
Figure 56. The left frame listel to the icon *Mikhail Malein and John the Warrior* in the process of recreating the loss of carved and ornamental decor in authentic material

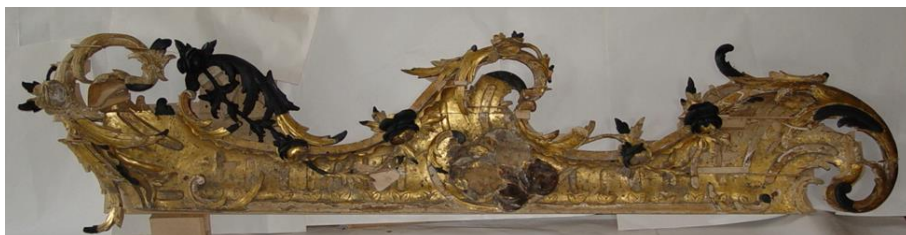
Figure 58. The right frame listel to the icon *Mikhail Malein and John the Warrior* in the process of modeling the loss of carved and ornamental decor

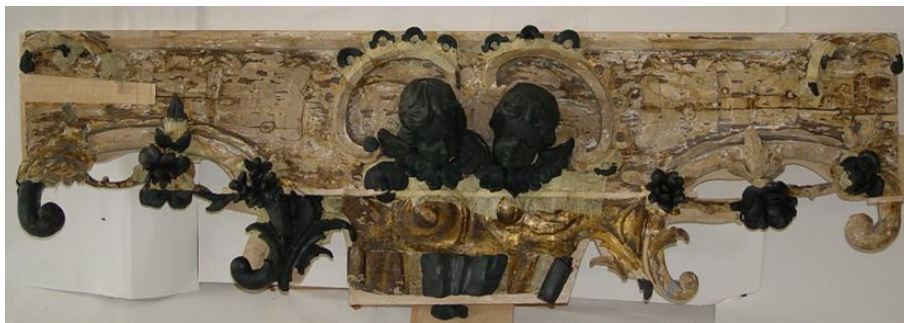
Figure 60. The lower frame listel to the icon *Mikhail Malein and John the Warrior*. Modelling the loss of carved decor in plasticine

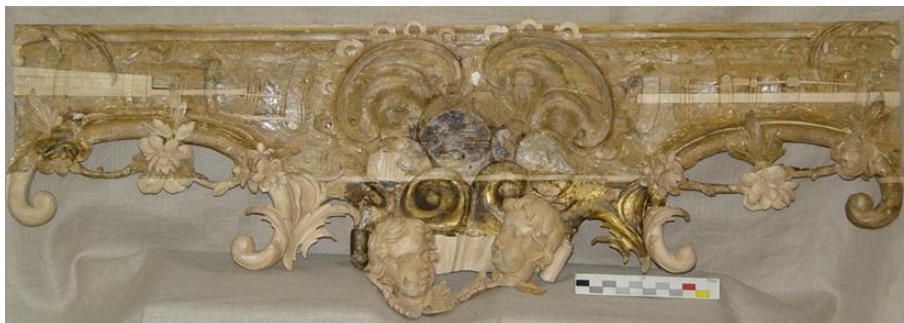
Figure 61. The lower frame listel to the icon *Mikhail Malein and John the Warrior* after recreating the carved and ornamental decor

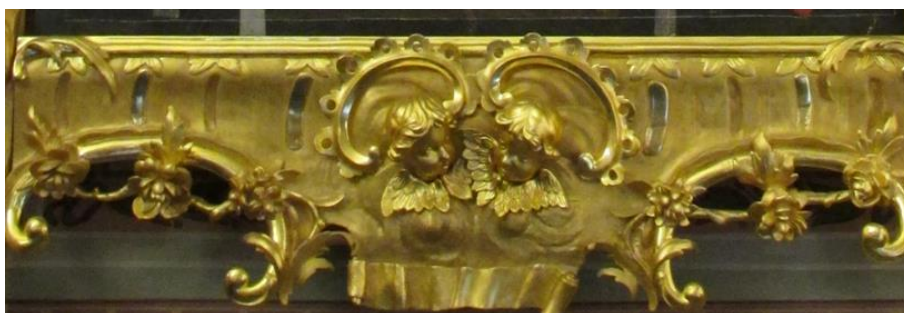
Figure 62. The lower frame listel to the icon *Mikhail Malein and John the Warrior* after a comprehensive restoration

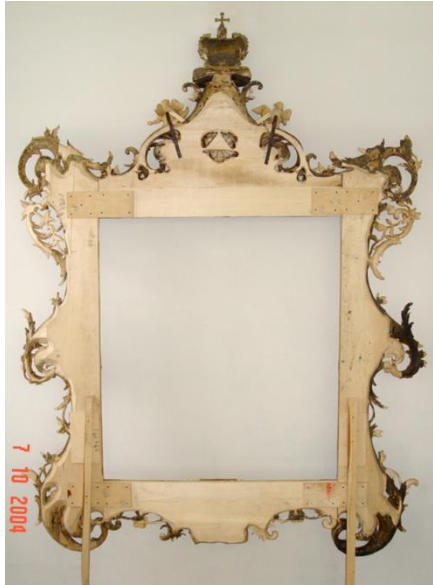
Figure 63. General view of the back side of the frame to the temple icon *Mikhail Malein and John the Warrior* in the process of duplicating the base and dry assembly of the frame

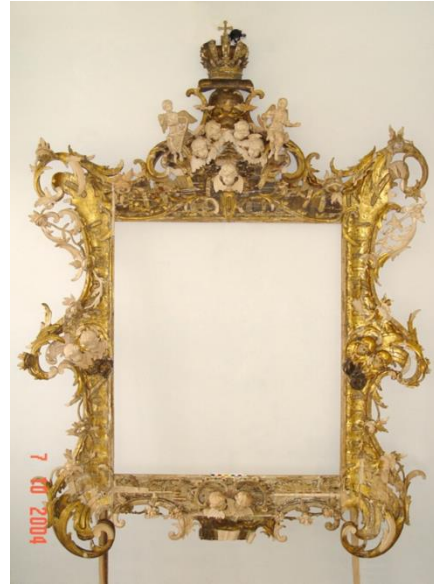
Figure 64. General view of the front side of the frame to the temple icon *Mikhail Malein and John the Warrior* in the process of restoration – recreation of carved and sculptural decor

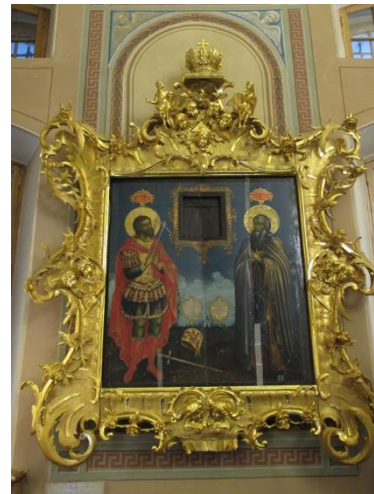
Figure 66. General view of the temple icon *Mikhail Malein and John the Warrior* in a frame after a comprehensive restoration of carved ornamental and sculptural decoration with gilding of two types without the icon of the *Vladimir Mother of God* and the frame to it in the upper part
